# Aqua (Scotland) Ltd

## Modified Van For Window Cleaning

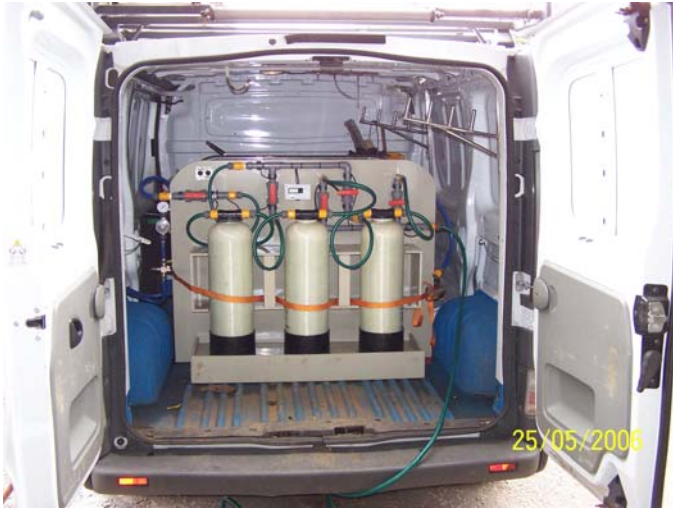
Newly installed into the rear of a Renault van. We manufactured the mounting panel and installed the three vessels to be configured as follows:

- Carbon filter
- Primary Resin filter
- Secondary resin filter

This allowed the system the capacity for change over in the field should the water quality drop off due to increased TDS readings at the pole / brush.

The expired vessel is then removed back at base and a new vessel fitted so there is no interruption to work.

The storage tank is situated behind the vessels and it can be seen that there is still plenty of storage room before reaching the rear doors

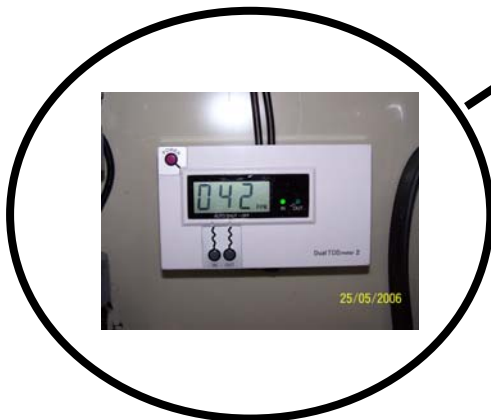
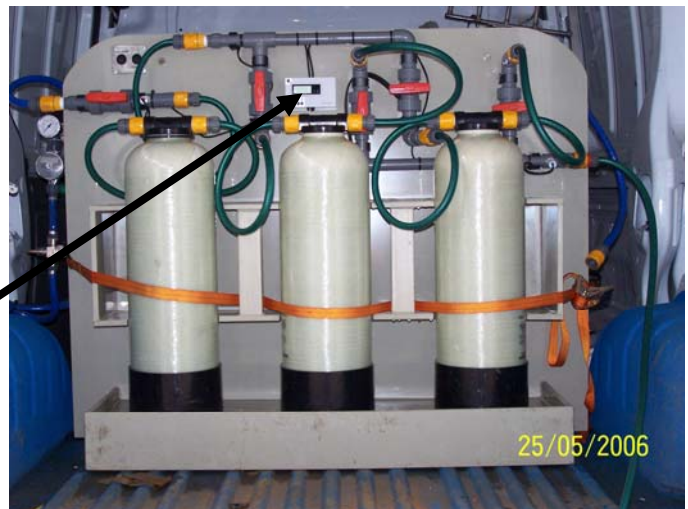
In this picture the in-line two channel TDS meter can be seen. This allows quick monitoring of the incoming water quality in the tank or from the mains and the outgoing quality of the water to the pole / brush.
